3-YEAR ASBESTOS RE-INSPECTION REPORT

WEST SCRANTON HIGH SCHOOL SCRANTON, PA

**SCRANTON SCHOOL DISTRICT
425 North Washington Avenue
Scranton, Pa. 18505**

PROJECT: #SSD.19_751

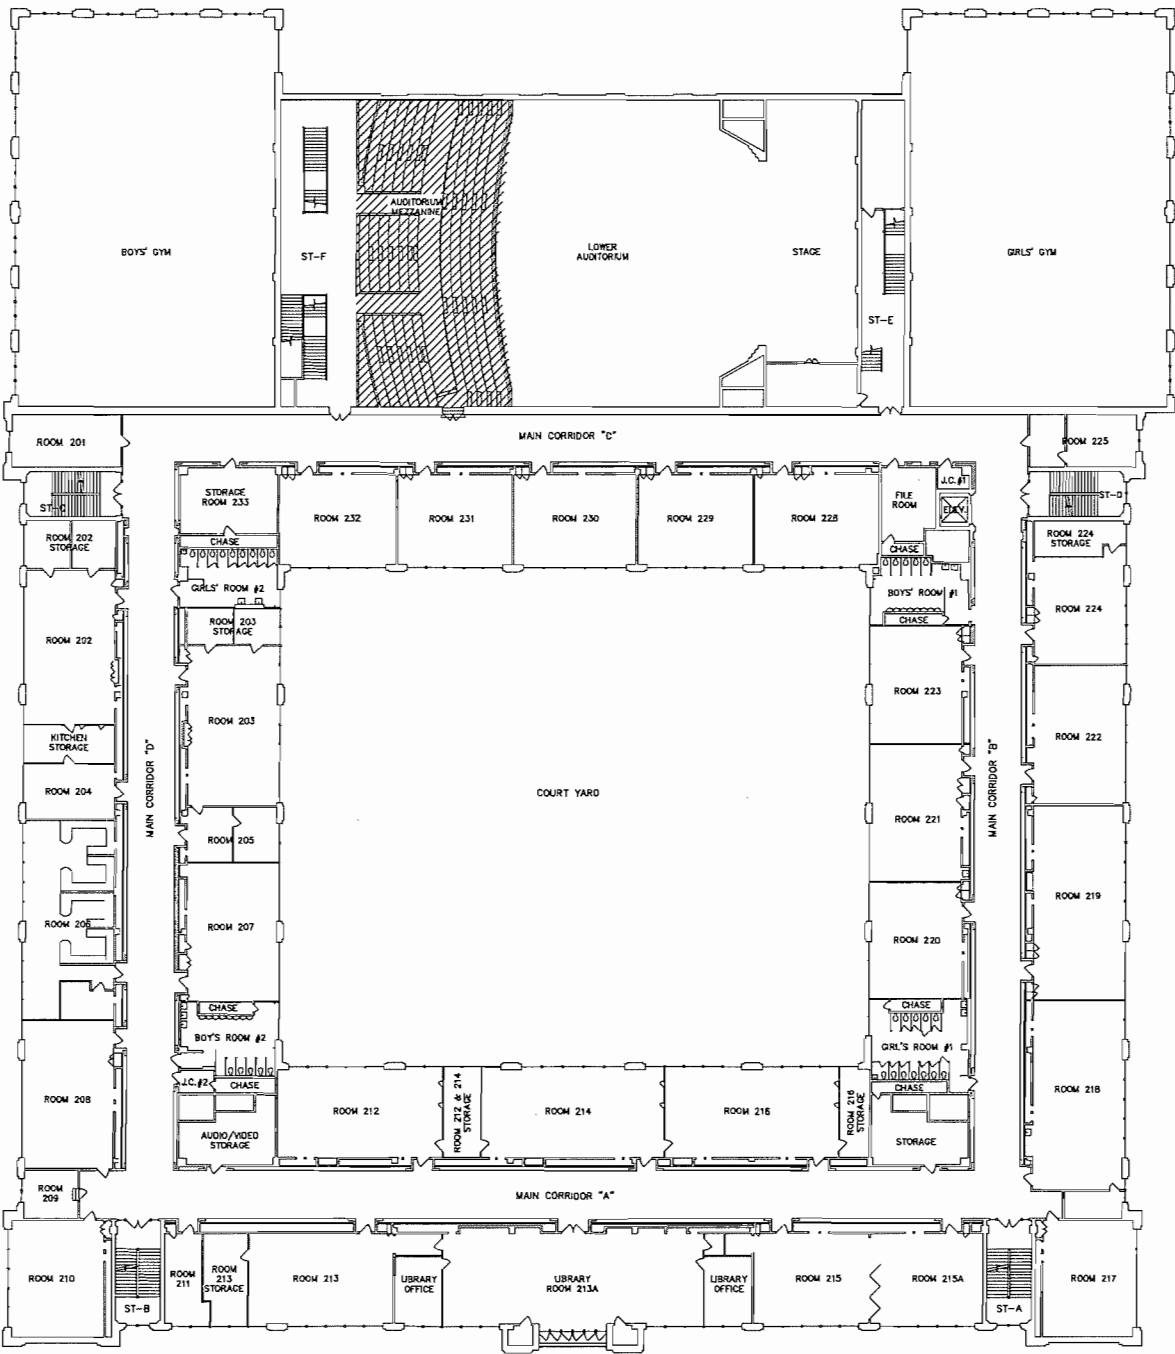
DRAWING No.:
A
1

SURFACING ASBESTOS CONTAINING MATERIALS

KEY - SURFACING ACM

- EXTERIOR COATING ON SINKS

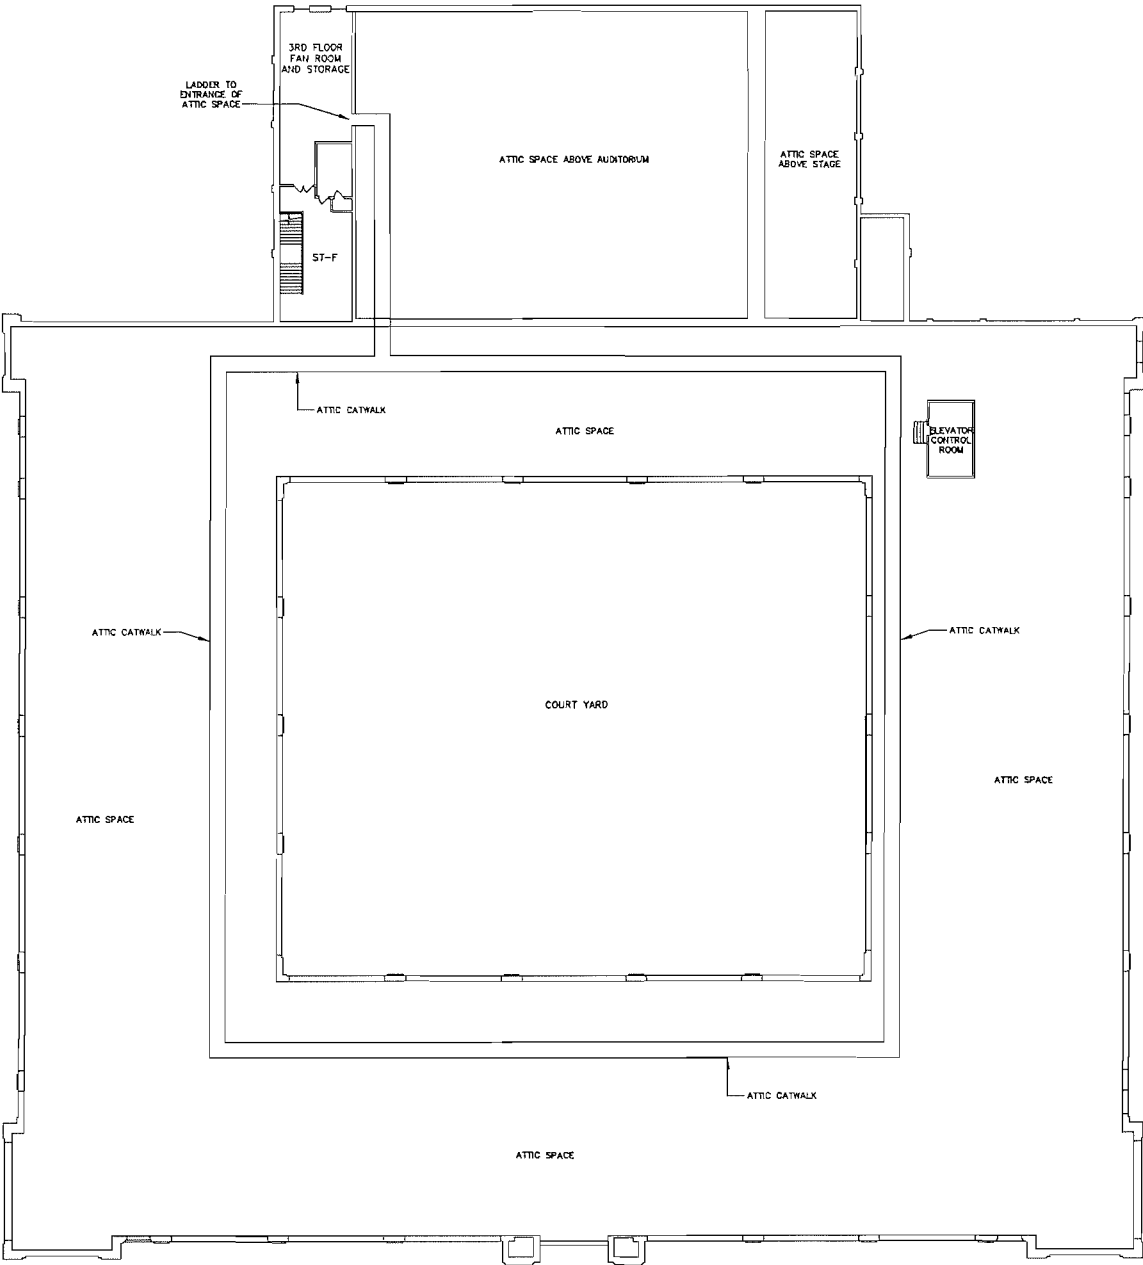
DRAWING No.:
**A
2**

KEY — SURFACING ACM
ASBESTOS CONTAINING
SURFACING MATERIALS WERE
NOT FOUND ON THIS LEVEL

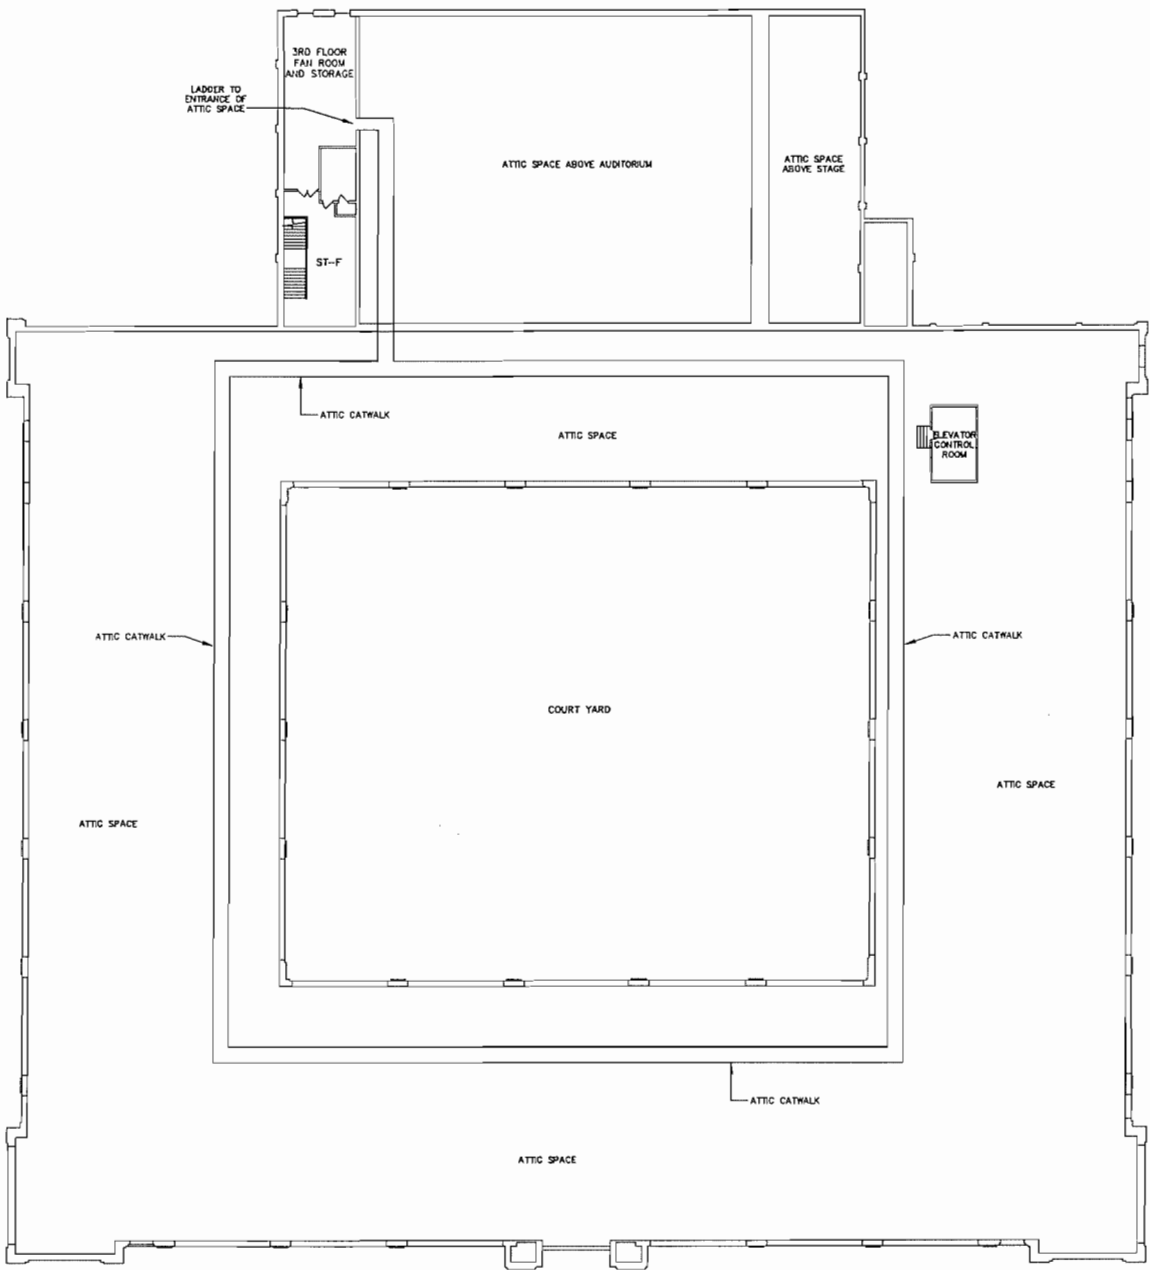
DRAWING No.: A

KEY — MISCELLANEOUS ACM
ASBESTOS CONTAINING
MISCELLANEOUS MATERIALS WERE
NOT FOUND ON THIS LEVEL
